## ABANDONED SITE PROJECT

## FINAL DISPOSITION

West Bent Bolt  
8623 S. Dice Road  
Santa Fe Springs, CA 90670

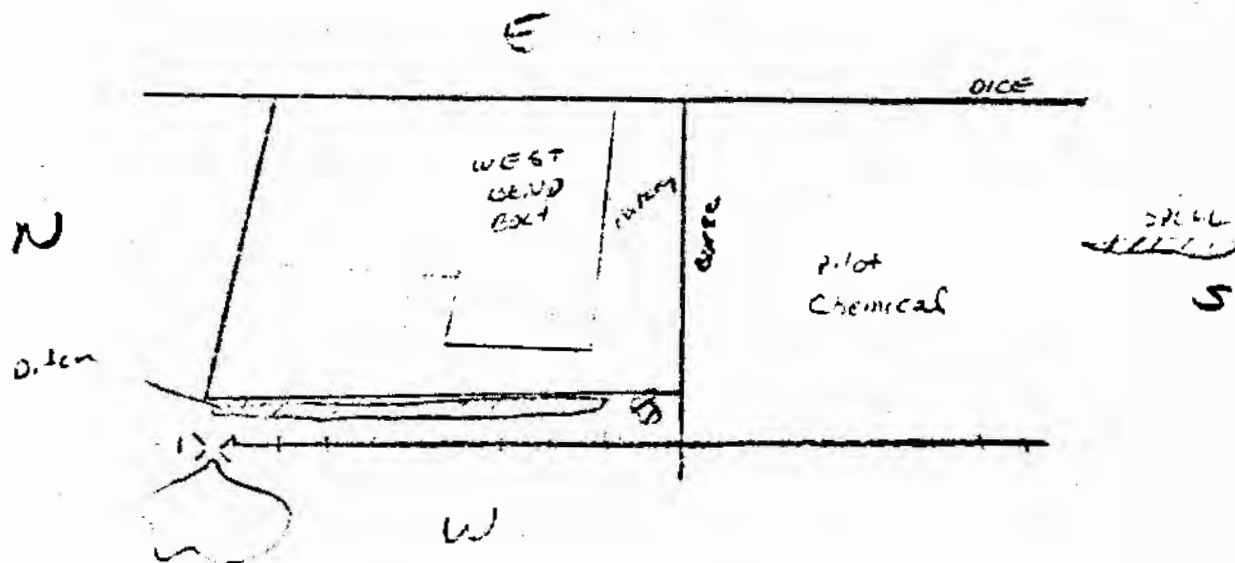
Parking area soil discolored with dark oily substance.

TYPE OF ACTION	NAME OF AGENCY OR CONTACT	TELEPHONE # OR ADDRESS	INFORMATION RECEIVED
Field Check 6-17-82	West Bent Bolt		<p>Problem still exists at this company. Dark oily substance in culvert noticed. A dead dog was noticed 30' from culvert.</p> <p>Photos were taken.</p>
